Rapid Watershed Assessment

Keweenaw Bay Indian Community Rapid Watershed Assessment News

Rapid Watershed Assessment, Keweenaw Bay Indian Community

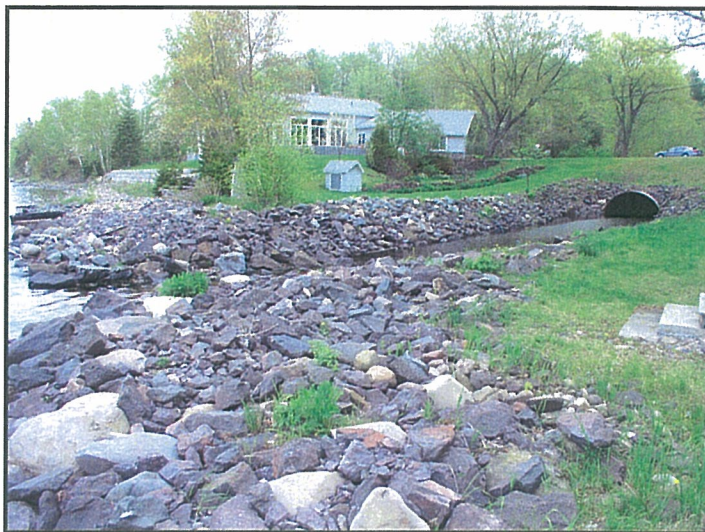
The stream crossing at Zeba Creek was remediated with a new arched culvert with a natural bottom designed for fish passage and rock armoring of the creek's outlet below the culvert which dramatically curtailed erosion.

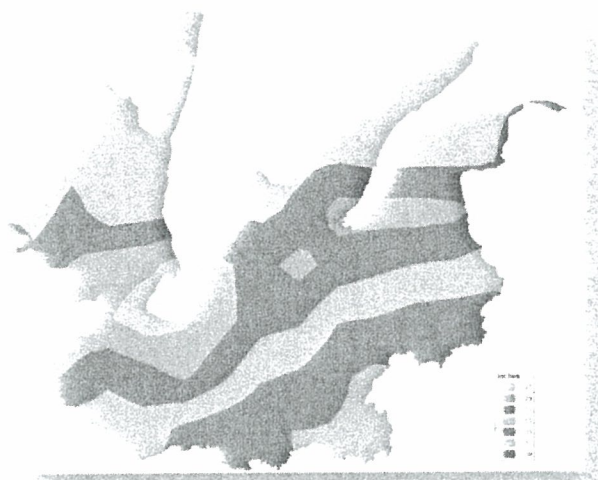
Map 4: Precipitation, Appendix 4

KBIC Rapid Watershed Assessment project area has an average annual precipitation of 32 inches (see Map 4).

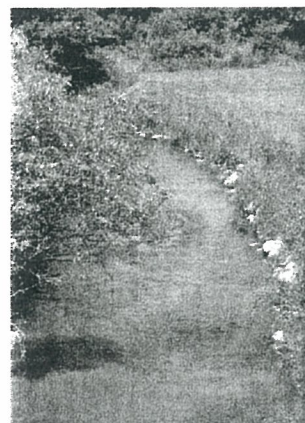
Future Conditions	Total Acres
Total Crop/Hay/Pasture Land	11,500
Total Forest Land	194,351
Other Land Use	2,977
Total Watershed Acres with Treatment (Current & New Implementation)	208,828
Estimated Acres: New Implementation	8400
Estimated increase in Participation (potential participation in time frame for implementation).	2%
Total participation Future	4%

The assessment matrix breaks down the current conditions and forecasts future conditions and costs by estimating the increase of participation in the time frame of implementation. The total average annual costs and present value of total average annual cost over 5 years is indicated within the cost summary.

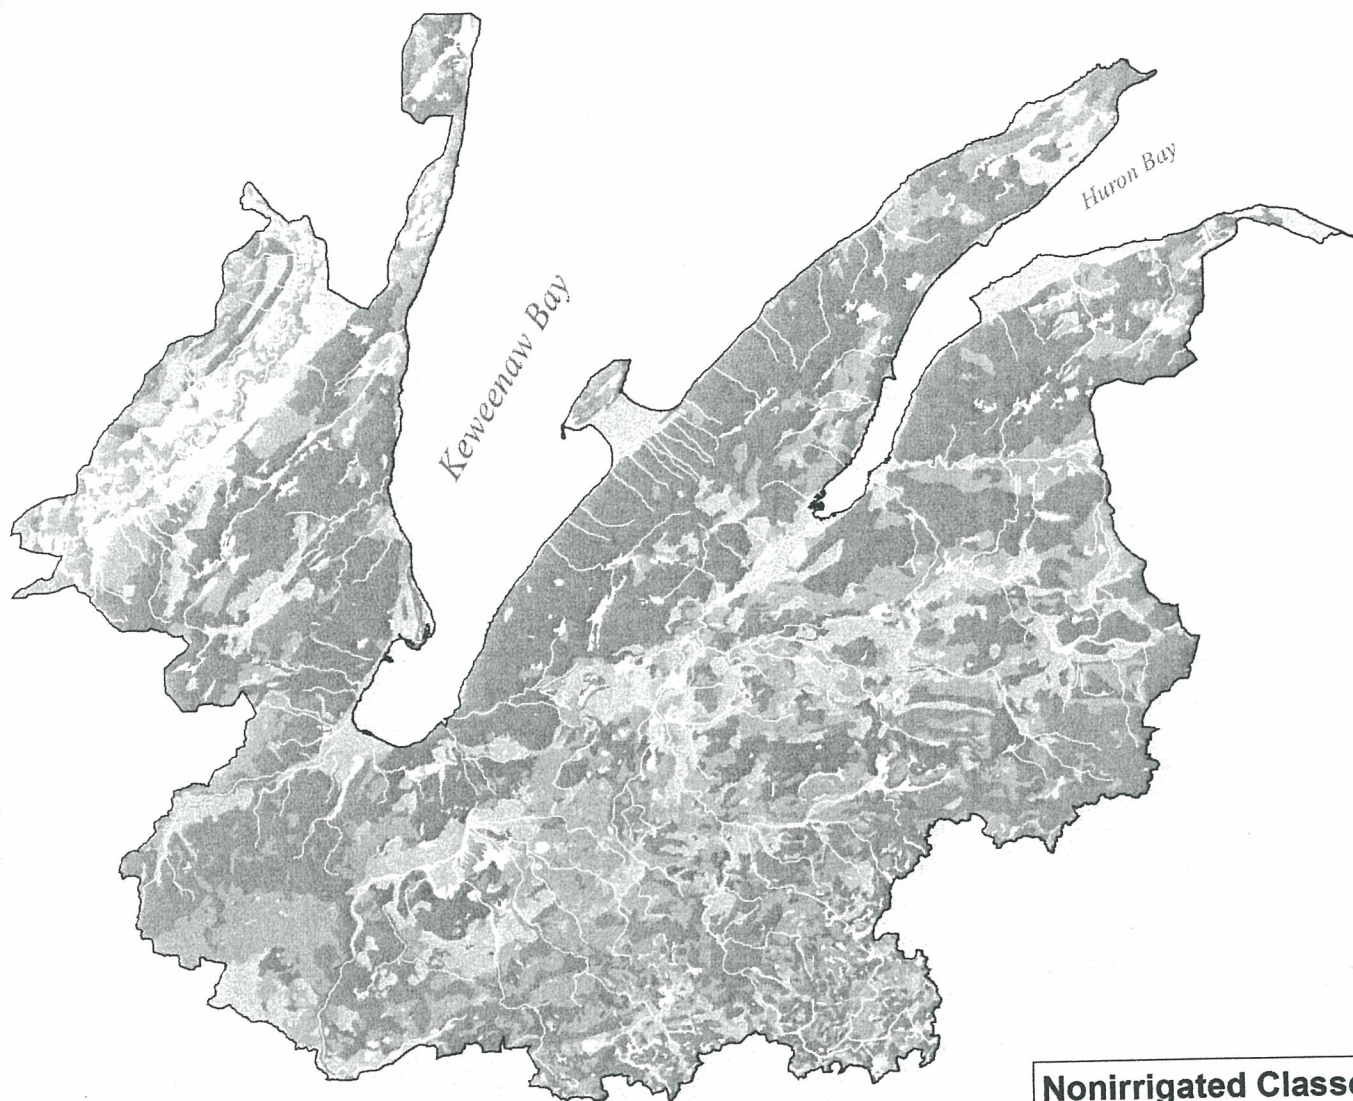
Nonirrigated Classes

-   Class 2
-   Class 3
-   Class 4
-   Class 5
-   Class 6
-   Class 7

Land capability classification shows, in a general way, the suitability of soils for most kinds of field crops. Crops that require special management are excluded. The soils are grouped according to their limitations for field crops, the risk of damage if they are used for crops, and the way they respond to management. The criteria used in grouping the soils do not include major and generally expensive land forming that would change slope, depth, or other characteristics of the soils, nor do they include possible but unlikely major reclamation projects. Capability classification is not a substitute for interpretations designed to show suitability and limitations of groups of soils for rangeland, forestland, or engineering purposes.

Class 5 soils have little or no hazard of erosion but have other limitations, impractical to remove, that limit their use mainly to pasture, range, forestland, or wildlife food and cover.

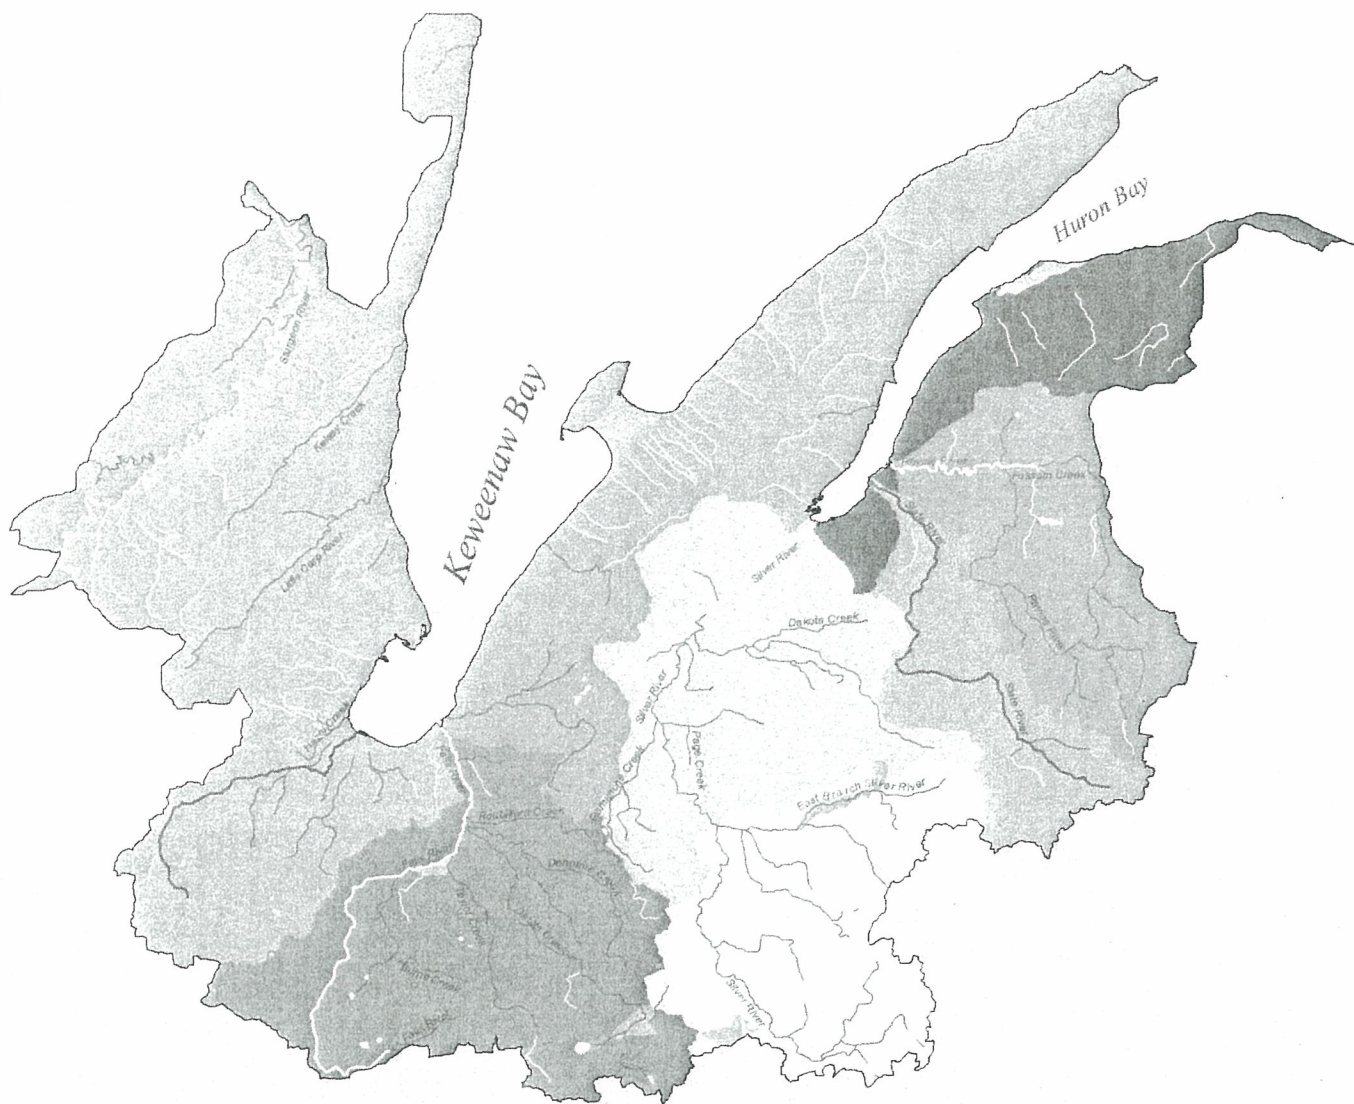
Keweenaw Bay Indian Community Rapid Watershed Assessment Fish Barriers (A - 11)

Sea Lamprey Infested		Subwatersheds	
	Sea Lamprey Infested Sometimes		East Branch Silver River-Silver River
	Intermittent River/Stream 280 Miles		Falls River
	Perennial River/Stream 354 Miles		Little Carp River-Frontal Keweenaw Bay
	Lake/Pond		Little Silver Creek-Frontal Keweenaw Bay
	Swamp/Marsh		Peterson Creek-Frontal Lake Superior
Sea Lamprey			Ravine River
72 Miles of Infested			Silver River
30 Miles of Moderately Infested			Slate River
			Town of Pelkie-Sturgeon River
